Manhole Inspection Summary

Manhole # S07YY1021MH

Insp Date: **9/15/06 12:42 PM**

Location Address: **5710 woodcrest ave**

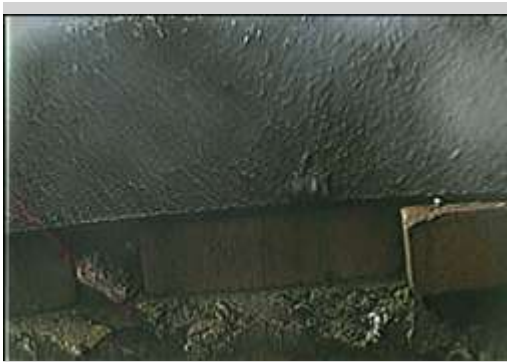
Defect

Condition: ☐ Sound ☐ Cracked ☐ Root Intrusion ☒ **Loose Brick** ☐ Deteriorated

Infiltration: ☐ None ☒ **Joint** ☐ Cracks ☐ Mortar ☐ Roots ☐ Wall

Adjustment infiltration and loose brick

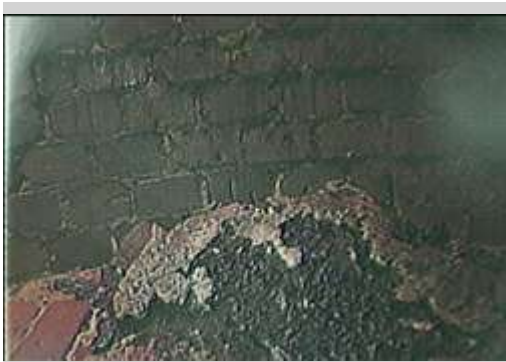
Defect

Bench Debris

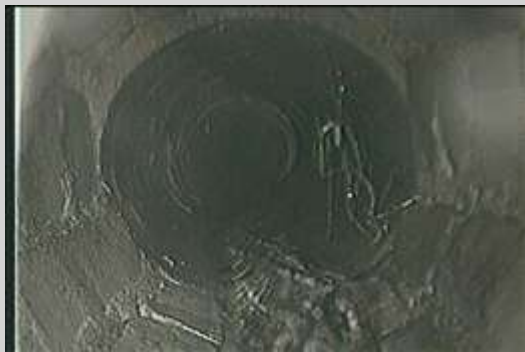
10 in. Circular Gravity Sewer Pipe Out @ 12 O'Clock

Infiltration: **None** Pipe Seal Cond: **Roots**
